# Manhole Inspection Summary

Manhole # S47I\_\_031MH

Insp Date: **4/23/08 9:34 AM**

**Location** Address: **403 s duncan st** Cross Street: **bank alley eastern**

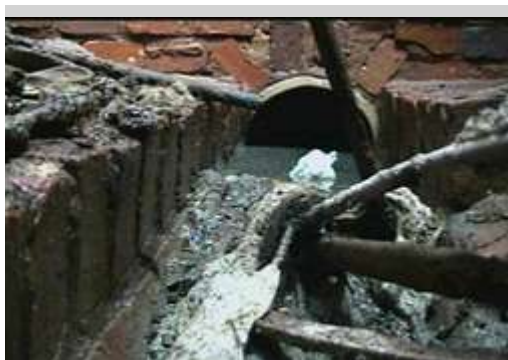
Defect 3

Condition: ☐ Sound ☐ Cracked ☐ Root Intrusion ☐ Deteriorated ☐ Leaks ☒ **Debris**

channel debris

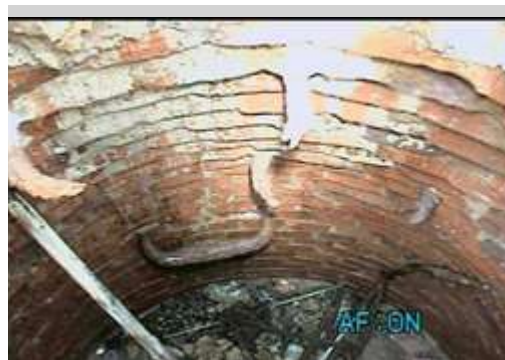
Defect 2

**Steps** Count: **3** Missing: **2** ☒ **Corroded**

corroded and missing stairs

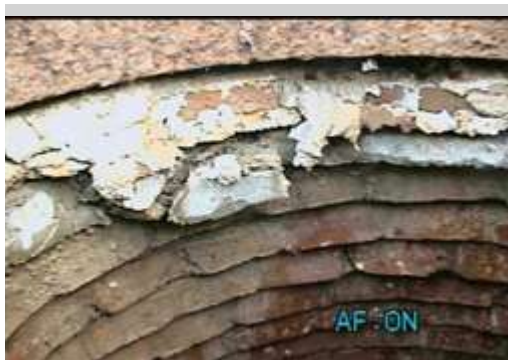
Defect 1

Condition: ☐ Sound ☐ Cracked ☐ Root Intrusion ☒ **Loose Brick** ☒ **Deteriorated**

deteriorated chimney

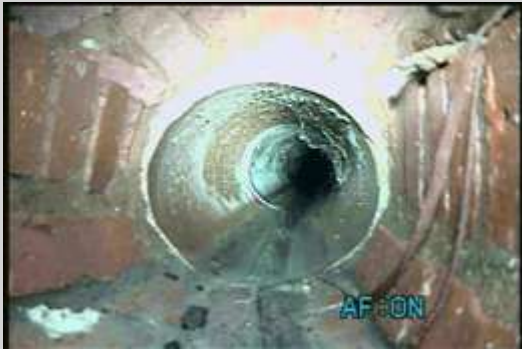
12 O'Clock Outflow

8 in. Circular Gravity Sewer  
Pipe Out @ 12 O'Clock

Invert Depth: **6.83** (ft.) Flow Characteristics: **Slow**

Infiltration: **None** Pipe Seal Cond: **Unknown**

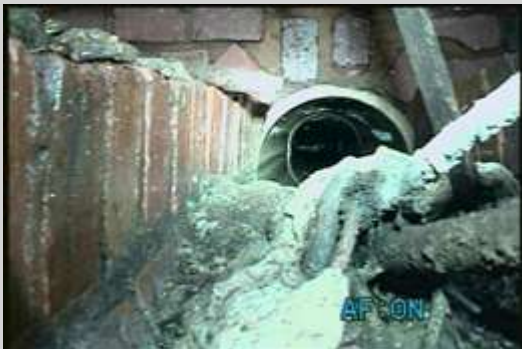
6 O'Clock Inflow

8 in. Circular Gravity Sewer  
Pipe In @ 6 O'Clock

Invert Depth: **6.66** (ft.) Flow Characteristics: **None**

Infiltration: **None** Pipe Seal Cond: **Unknown**

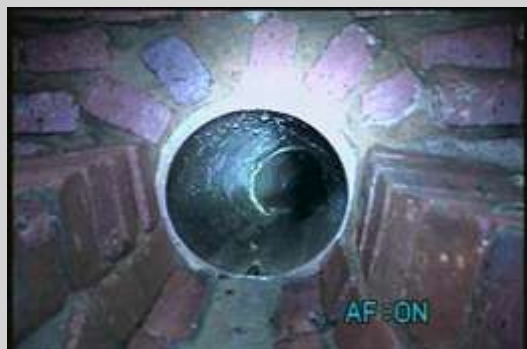
9 O'Clock Inflow

8 in. Circular Gravity Sewer  
Pipe In @ 9 O'Clock

Invert Depth: **6.50** (ft.) Flow Characteristics: **None**

Infiltration: **None** Pipe Seal Cond: **Unknown**
